**ENVIRONMENTAL MEMORANDUM**

**Red Chris Development Company Ltd.**  
200–580 Hornby Street, Vancouver, BC V6C 3B6

Date: Feb 9<sup>th</sup>, 2016

Re: Red Chris Monitoring Committee Environmental Report Jan 26 – Feb 9<sup>th</sup>, 2016

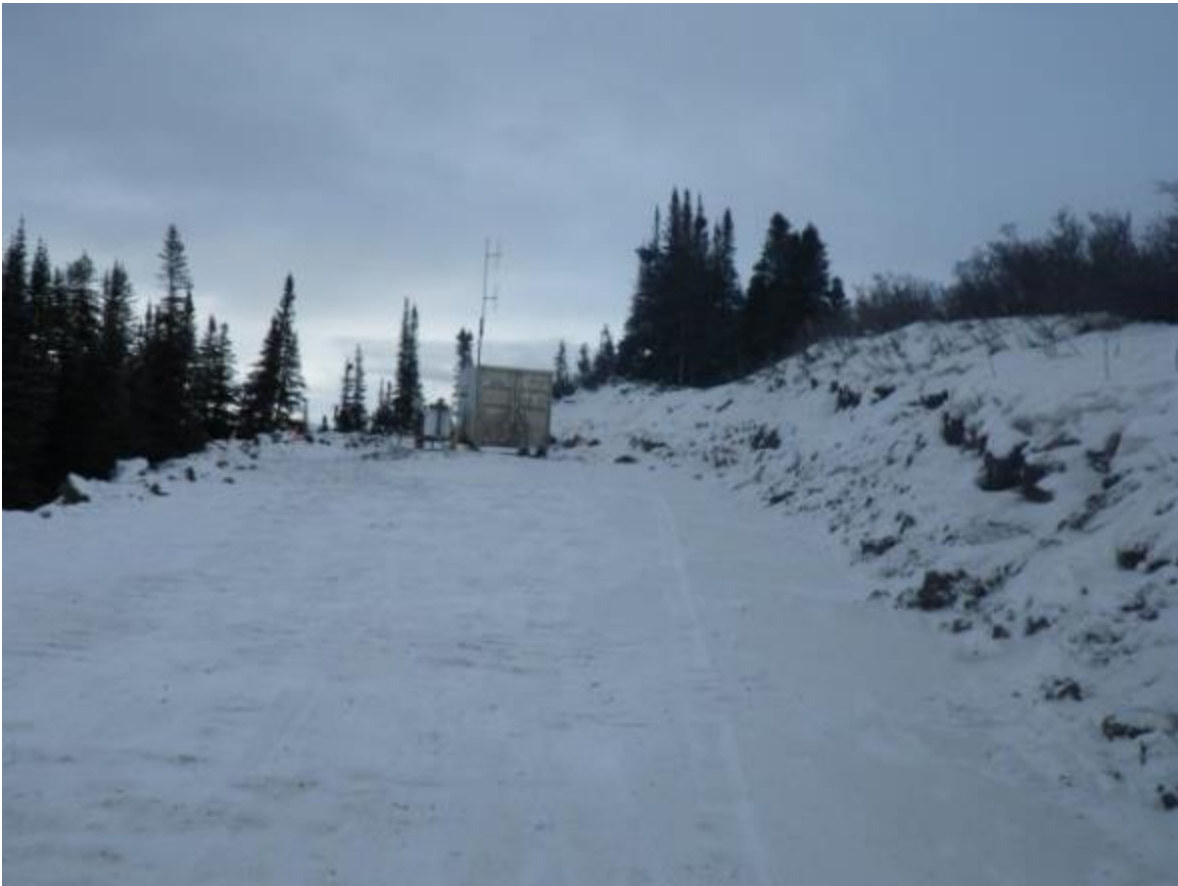
Pit Repeater channel tower successfully placed atop the highest point improving radio communication around the mine site.

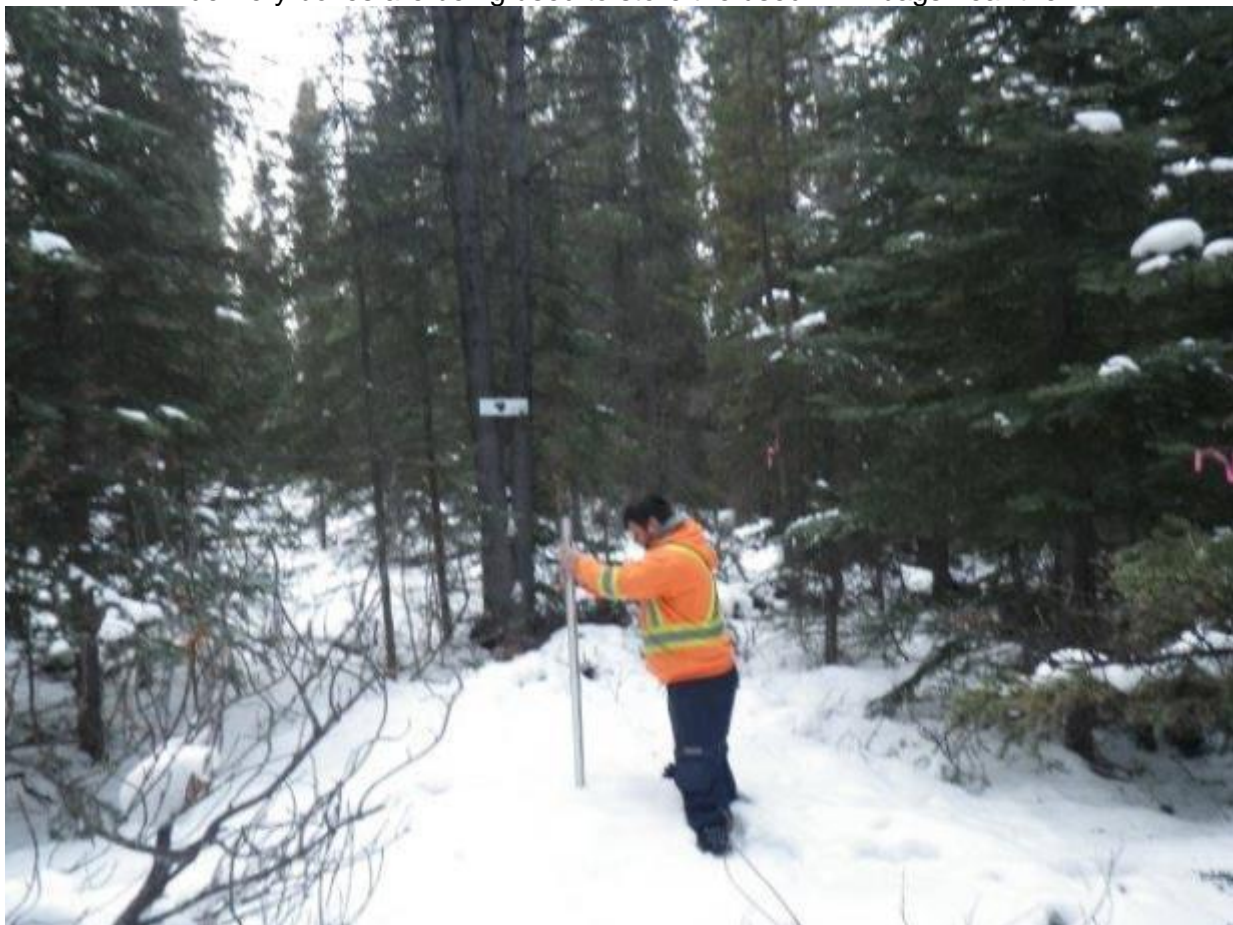
Snow samples for 2016 were collected from both new replacement sites, lower SSSDAM and upper SSRSA.

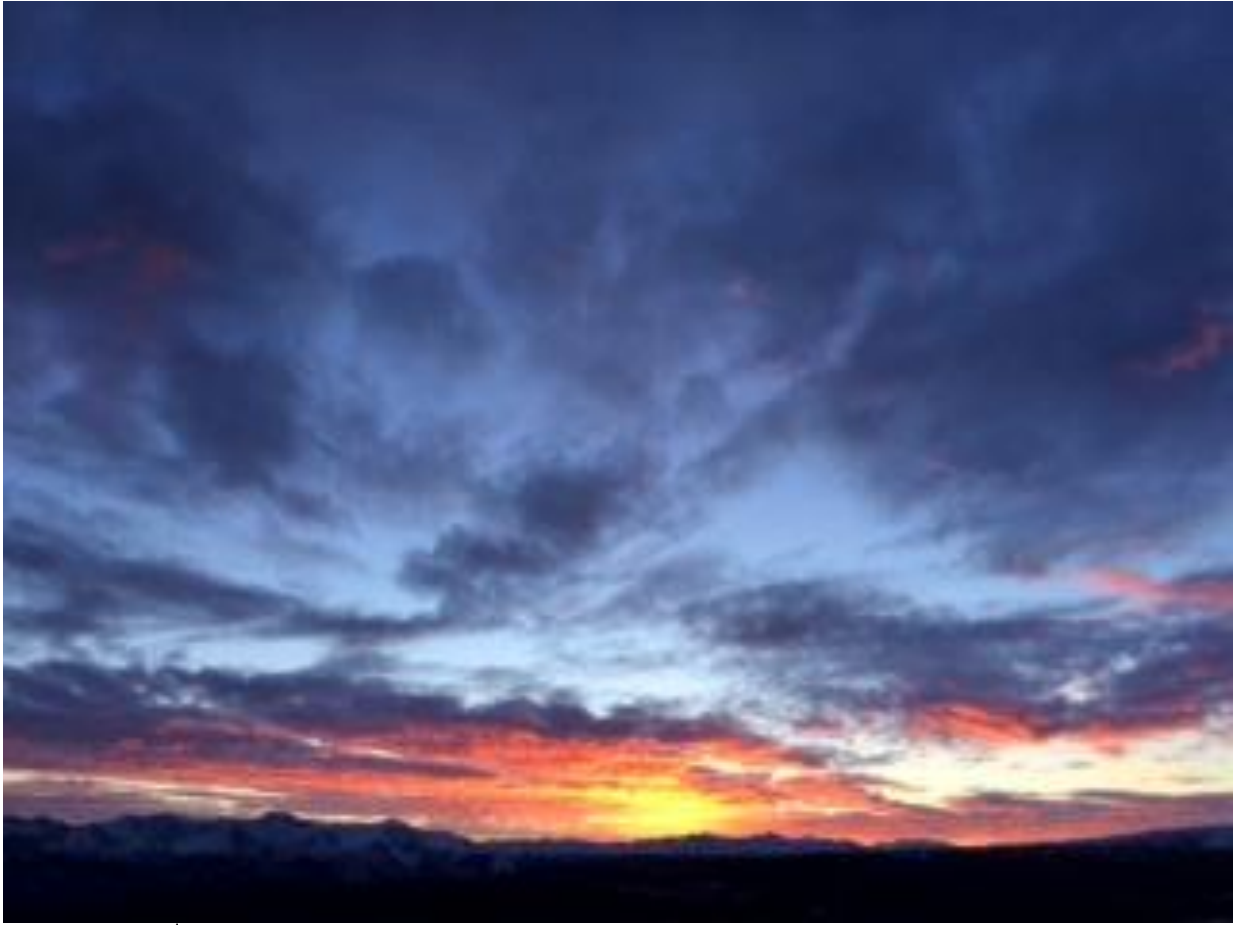
February 2<sup>nd</sup>, 2016 mourning view from the top of the TIA road looking at the spatsizi ranges.

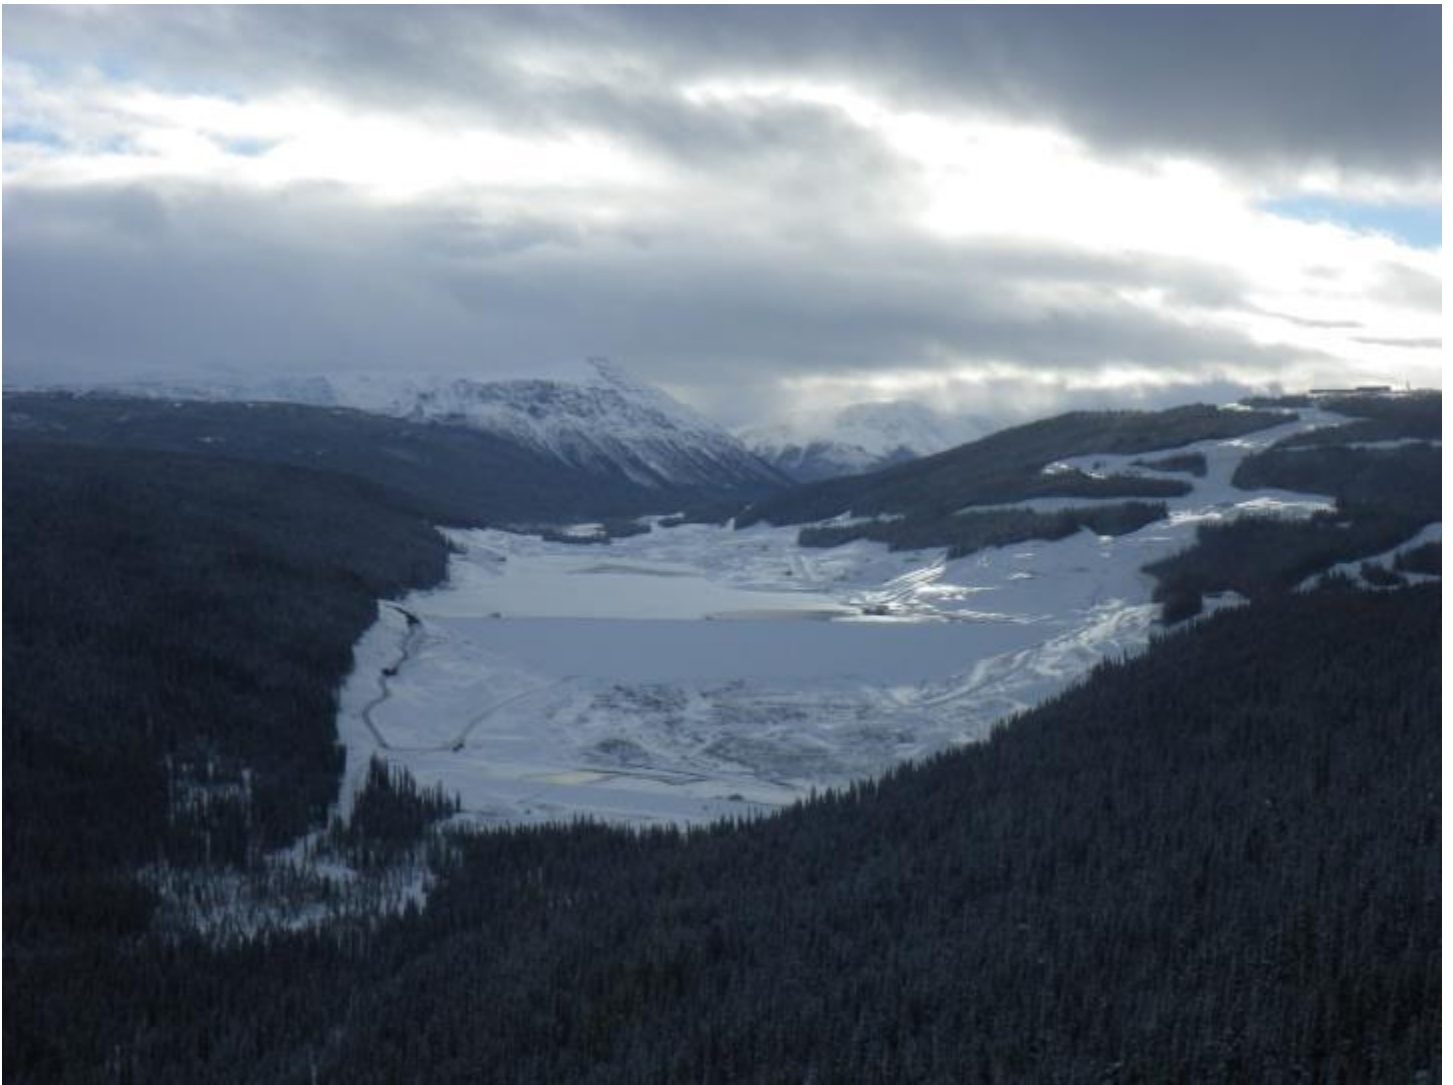
Looking south from the North Relcain Dam showing the vast size of the TIA almost to the North East Arm valley to the far left.
